A.U.W.E. Technical Note 192/65

A CORROSION STUDY ON MATERIALS
FOR USE WITH PHOSPHORUS AND SULPHUR BEARING FUELS.

EXAMINATION OF COMBUSTION CHAMBER COMPONENTS ETC.

(9) Technical note, (10) H. Goldie.

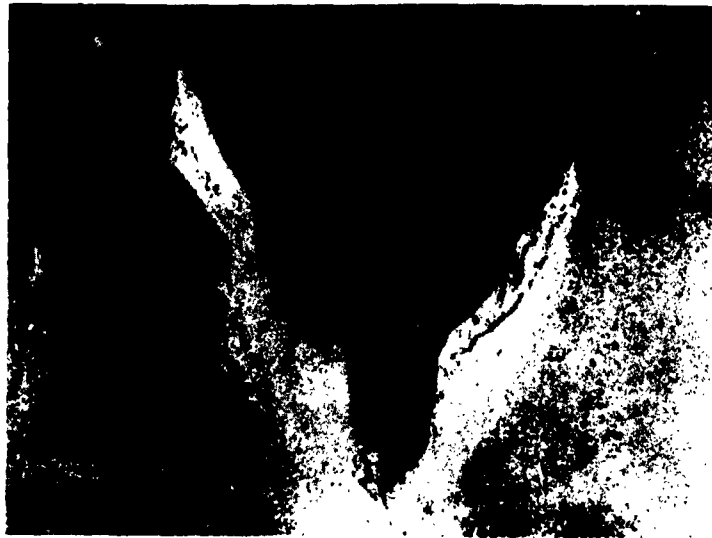
FIG 16

32. The leading edge of the blade suffered severe erosion while the centre had been virtually removed leaving a vee shaped groove. The apex of the groove almost reached the opposite edge of the blade (Figure 16).

EXPERIMENTAL TURBINE BLADE EN58J
PLACED IN EFFLUX FROM NOZZLE

34. It is considered that the damage to this component was caused by reaction between base metal and phosphoric acid (probably metaphosphoric vapour) ultimately resulting in the formation of low melting point phosphides. These compounds once formed would be rapidly removed by the action of the gas stream.

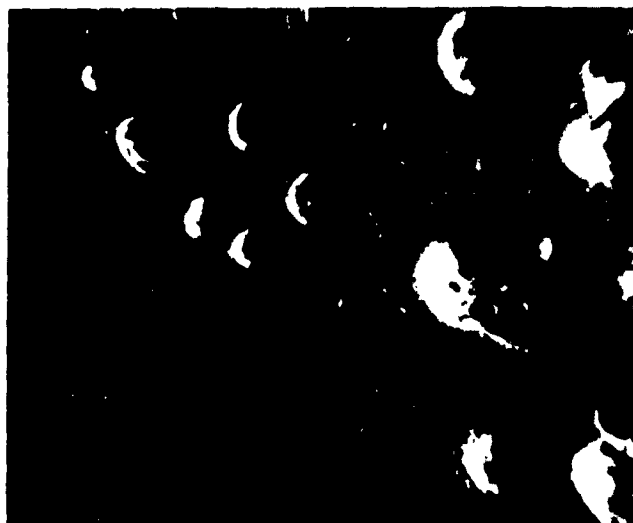
FIGS 22,23 &24

37. Electron Beam X-Ray microanalysis of the deposit showed that the iron content of the scale was 10% less than that of the base metal. The phosphorus and copper contents were found to be approximately 1%. Figure 22 shows the electron image of the area selected for analysis. Figures 23 and 24 are X-ray images for phosphorus and iron respectively.

38. Although phosphorus was found in the deposit, the eutectic matrix was considered to be essentially transformed Ledeburite. This structure probably resulted from a temperature exceeding the equilibrium liquidus i.e. for silver steel approximately 1350°C.
